Date: 26 Oct 2022

Oasis Circular No.: 2209

Subject: China MSA issued notice of correction to chart in respect of unidentified underwater objects off Fuzhou port and Ningde port

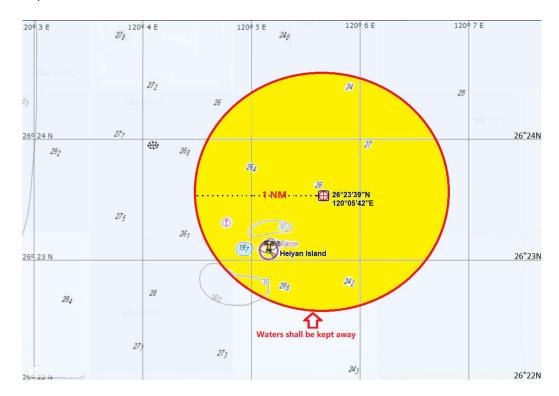
On 10 Oct 2022, China MSA issued No. 41 Notice of Correction to Channel Charts of Chinese Coastal Ports, in which they requested ships to remark the warning statement "Unidentified underwater objects were found in northeastern waters of Heiyan Island, Sansha'ao, Lianjiang, Taiwan Strait, within a radius of one nautical mile from the center of the circle: 26°23′39″, 120°05′42″E″ on the 3 relevant nautical charts, including No. 62001 (2022-970), No. 62151 (2022-202) and No. 2310 (2022-904). The source of this correction notice is No. 32/22 Navigation Warning issued by Fujian MSA on 10 Sep 2022. Details are illustrated as follows:

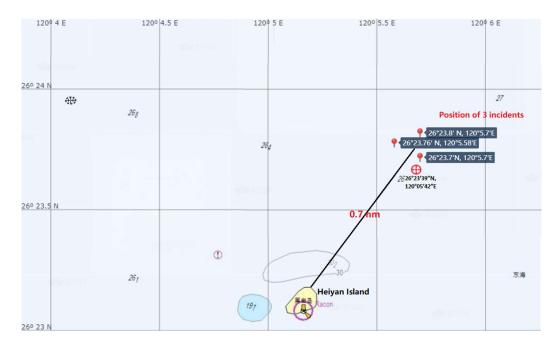
Before the issuance of the above Navigation Warning No. 32/22, 3 major grounding accidents occurred in this area during the years from 2020 to 2022, which caused

serious damages to the ships' hulls and necessitated complex salvage operations. The draught of those ships at the time of grounding varied from about 7 metres to 15 metres, with two ships laden whilst the third one in ballast. The positions of these 3 grounding incidents are listed as follows and illustrated below:

- 1. 26°23.7′N, 120°5.7′E
- 2. 26°23.8′ N, 120°5.7′E
- 3. 26°23.76′ N, 120°5.58′E

Positions of 3 grounding incidents from 2020 to 2022

Ships which plan to call Fuzhou Port (including Luoyuan Port, Kemen Port, Huadong Shipyard and Ningde Port (including Zhangwan Terminal, Datang Powplant Terminal, Dingxin Terminal, etc) shall add the above warning statement in the nautical chart before the voyage commences and keep away from those waters when the ship enters into or departs from the aforesaid terminals and shipyards. A map of this area is appended below for your ready reference.

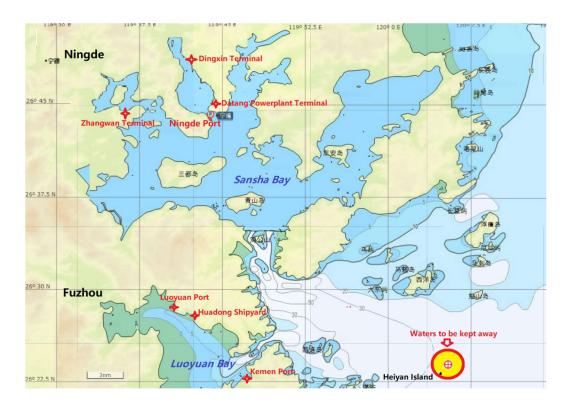
Terminals/shipyard of Fuzhou Port and Ningde Port

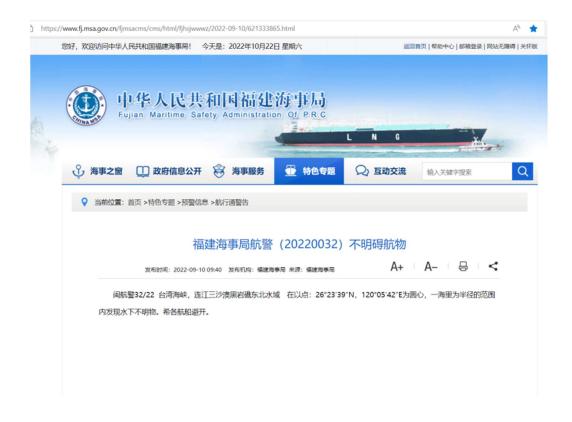
Fujian Navigation Warning 32/22: Unidentified underwater objects were found in the northeastern waters of Heiyan Island, Sansha'ao, Lianjiang, Taiwan Strait, within a circle with a radius of one nautical mile and centred at 26 $^{\circ}$ 23 $^{\prime}$ 39 $^{\prime\prime}$ N, 120 $^{\circ}$ 05 $^{\prime}$ 42 $^{\prime\prime}$ E. All ships shall keep away from the waters.
