BIG ORANGE XVIII: COLLISION IN EKOFISK FIELD

The Norwegian Petroleum Safety Authority (PSA) published a comprehensive report in October 2009 about the collision of the well service ship *Big Orange XVIII* with the Ekofisk 2/4-W platform.

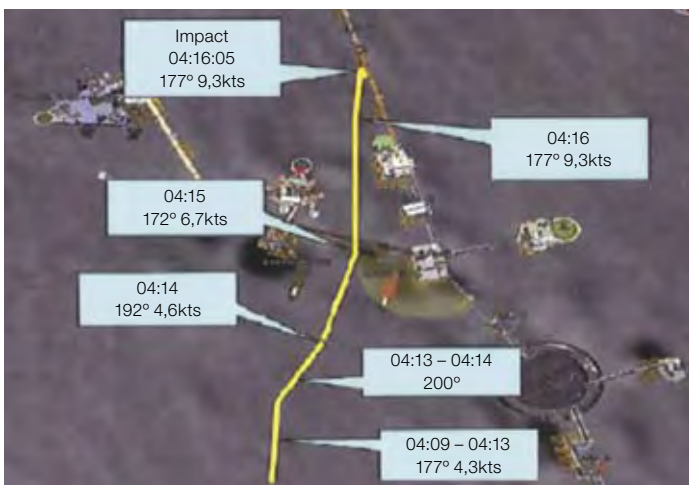
The course of Big Orange XVIII based on radar plot from Ekofisk Radar and AIS

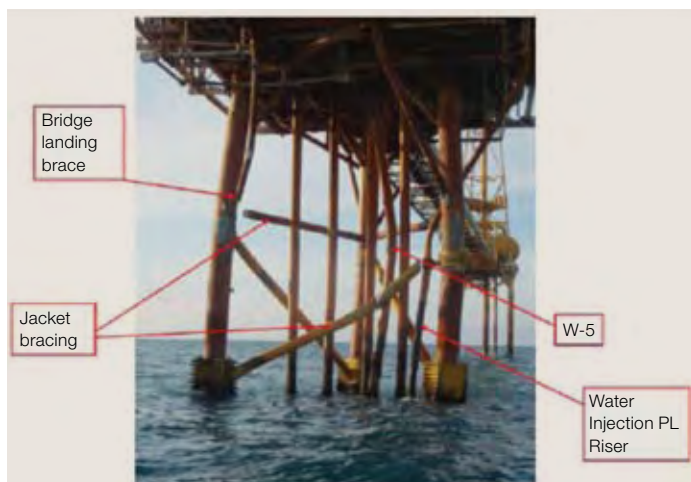
Significant material damage was caused to the Ekofisk 2/4-W injection facility.

Damage to Ekofisk 2/4's load-bearing structure, conductor and riser (source: ConocoPhillips)
