# Standard Safety

## Special Edition - Navigation

September 2009

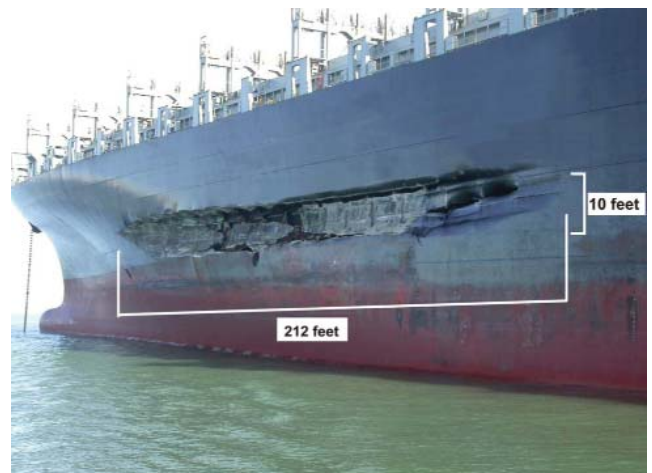
#### COSCO BUSAN damage

The *Cosco Busan*, whilst navigating from the berth to sea with a pilot on board in restricted visibility, collided at 0830 hours with one of the base towers supporting the San Francisco-Oakland Bay Bridge, breaching a number of the ship's fuel oil tanks. This resulted in a spill of about 53,500 gallons of fuel oil, contaminating some 26 miles of shoreline. The total cost of the oil spill clean-up was in excess of \$70m, bridge repair \$1.5m and repair to the ship \$2.1m.

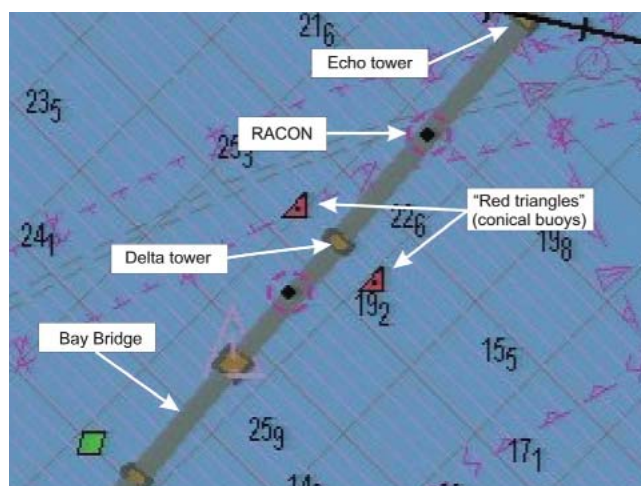
### The Bay Bridge as displayed on the electronic chart

- the master did not enquire from the pilot about the expected passage from the berth
- the pilot was confused as to what the 'red triangles' signified on the electronic chart (these indicated buoys)

- the electronic chart system (ECS) was not a certified Electronic Chart Display (ECD) and Information System (ECDIS)
- the Voyage Management System (VMS) included an Automatic Navigation and Track Keeping System (ANTS) module, which determined the ship's position and monitored the ship's advance against the planned track but it was immobilised

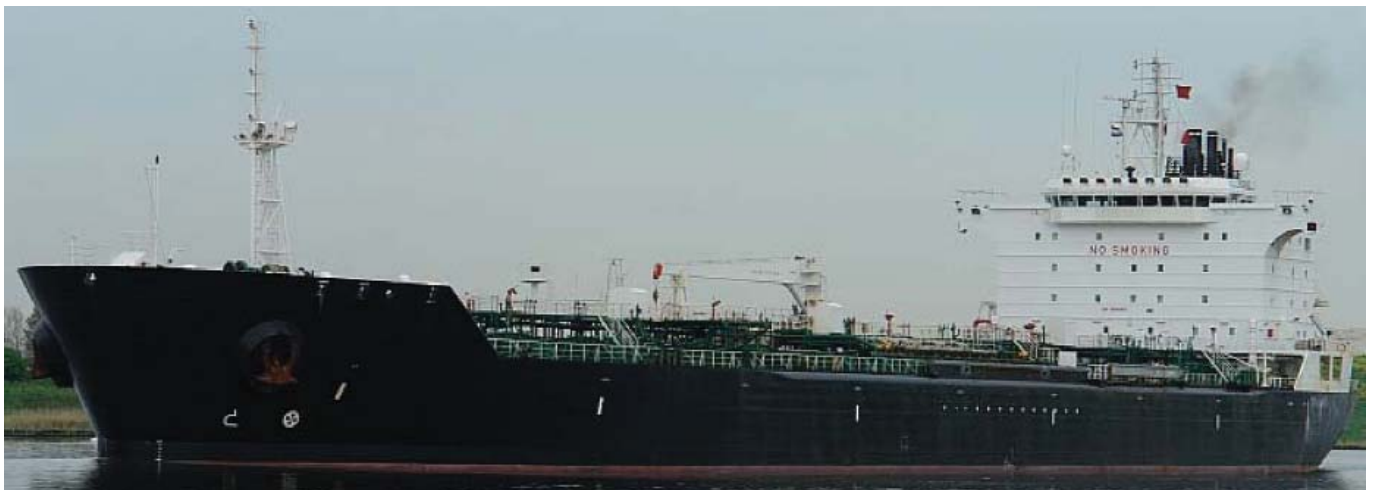
A GROUNDING

A fully laden products tanker with a draft of 12 metres on a regular run grounded in broad daylight whilst proceeding to a small Caribbean port, an hour away from the pilot station. The ship was operated by a major tanker operator, the bridge equipment was fully operational, including ECDIS with track control system, 2 x GPS, and S and X band radars. A comprehensive passage plan had been drawn up, parallel indexing marked and hazards shaded on the largest-scale charts. Position fixes using radar bearings and ranges were taken at least every 10 minutes. However, the normal passage plan had been amended by the master to reduce the steaming distance marginally and this brought the ship closer to the land, from six miles to less than two miles.

The watch was handed over to a junior, inexperienced navigating officer of the watch (OOW) in the correct manner and one hour's notice was given to the engine room. The OOW called the pilots to make contact a number of times over the next hour without success and the master, who was in his cabin completing paper work, was kept advised. In accordance with the passage plan, the ECDIS alarms indicated the waypoint alteration of course and the OOW ordered the new course to be steered in hand steering by the lookout, rather than allowing the track control system to carry out the alteration of course. The master arrived on the bridge, rang standby engines and took the 'con'. Moments later a heavy shuddering was heard and the ship was firmly aground.

- ensure sufficient experienced personnel on the bridge
- OOW should navigate according to the passage plan
- OOW should comply with the master's standing orders
- OOW should use parallel indexing techniques according to company bridge SMS and master's standing orders
- the master should comply with his own standing orders
- OOW should allow for the wind effect on the alteration of course
- any amendments to the passage plan should consider the risks of bringing the ship closer to shallow water, giving less margin for error

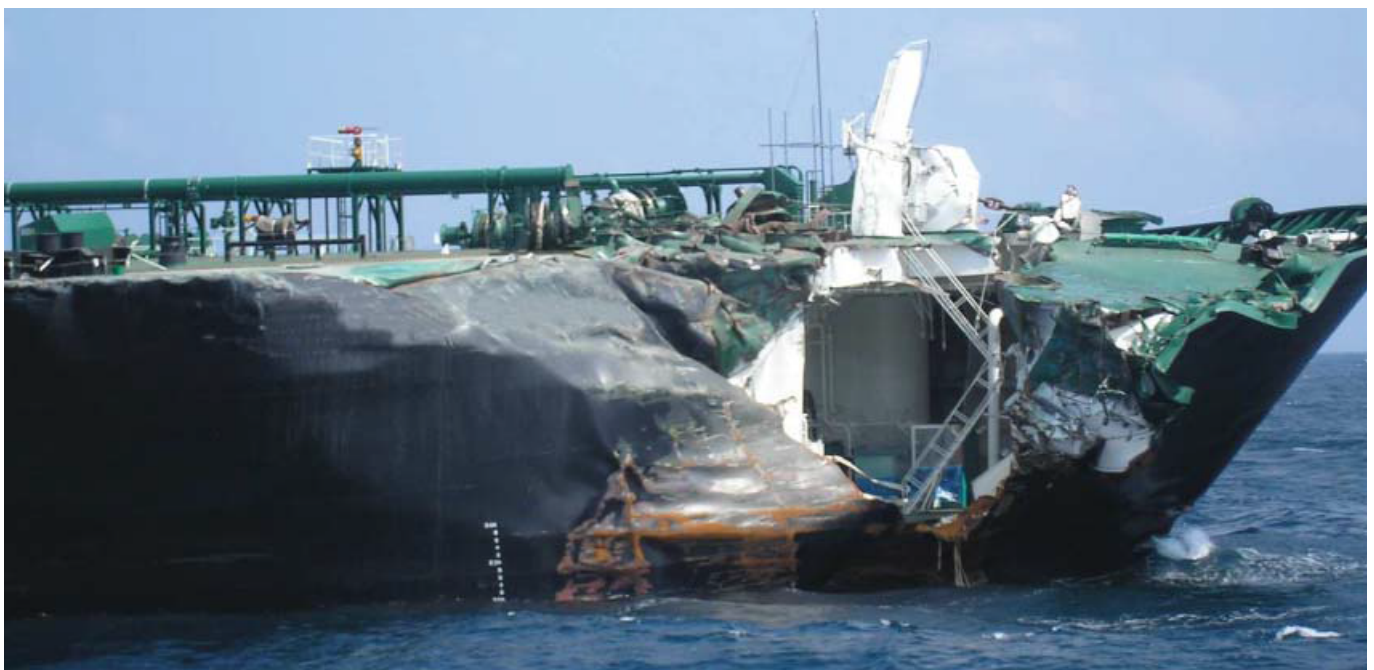
A COLLISION

There was extensive damage to both ships, but no loss of life or pollution. It could have been much more serious.

- owners should ensure that OOWs have a good knowledge of the COLREGS
- OOWs should have regular sessions and training on bridge simulators to ensure they are qualified in the use of ARPA and AIS
- regular sessions on bridge simulators to ensure OOWs can appropriately apply the COLREGS
- OOWs using E-navigation equipment (ECDIS, etc) must be trained
- OOWs must understand the importance of calling the master in time
- VHF use is not a substitute to complying with the COLREGS
