Standard Safety

April 2009

Special Feature - Stowaways

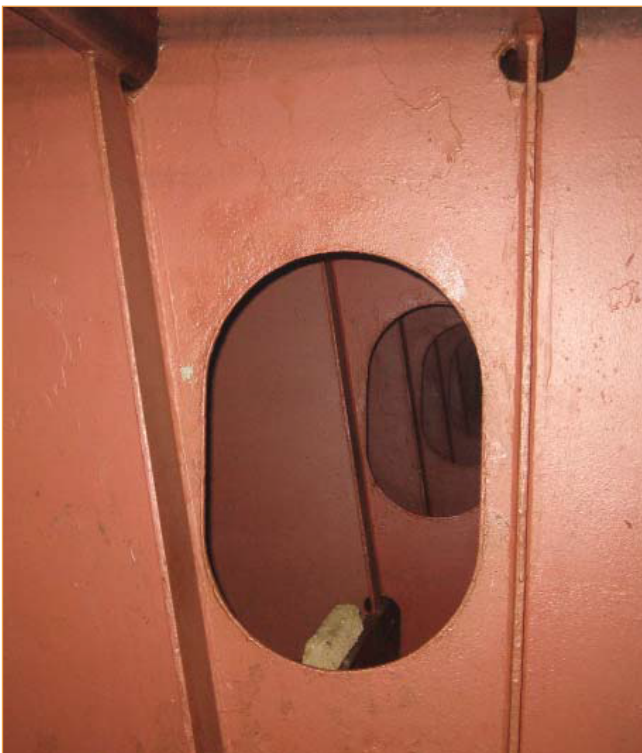
On arrival at the discharge port, when carrying out the draft survey it was calculated that the ship had substantially more cargo onboard than when it left the load port three weeks earlier. Of course this was not possible and it transpired that there was over 1,000 tonnes of sea water ballast onboard and this was all in one hold. The cement had by this time started to harden; there was a hold full of solid and solidifying condemned cement cargo, which took six weeks to dig out. Total costs, excluding off hire, were over \$1.5m.

After inspection a corrosion hole was found in the connecting trunking between the double bottom tank and the upper wing tanks.

- consider whether to ballast at all when loaded with water sensitive cargo; ballast water can leak through tank top manhole lids, poor bilge and ballast valves, faulty non return valves, damaged air and sounding pipes, poor or damaged ballast tank or hold bulkheads

- ensure that regular soundings of all accessible spaces, including hold bilges, duct keels, bow thruster spaces, tanks, cofferdams and voids are taken at all times at sea (weather permitting). Monitoring the watertight integrity of the ship is a basic seamanship task

- all ships must have a rigorous tank inspection programme, particularly ballast tanks. This must be a part of the Planned Maintenance System (PMS). It needs to be recorded and monitored by the shore managers. A tank inspection schedule should be drawn up and the officers and crew involved, trained in what should be inspected and recorded

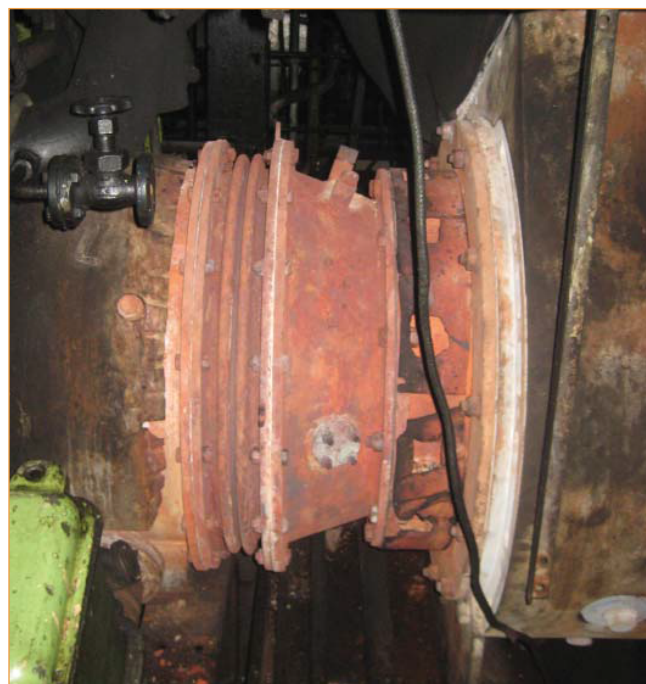
During a number of recent condition survey inspections carried out by the club's loss prevention surveyors, a number of main engine and generator exhausts have been identified as not being adequately insulated and covered. Some of these deficiencies were even found on passenger ferries. Not always considered a P&I matter and more often thought of coming under 'Hull and Machinery', the effects of a engine room fire have a direct impact on the safety of the crew and passengers, and can result in the ship grounding (wreck removal), and / or a general average situation where the club could be liable for the cargo interests proportion of general average.

It is universally accepted that the majority of fires in engine rooms are caused by a lubricating or fuel oil pipe failing and spraying oil onto a hot exhaust. This could be because of a failed pipe connection or olive, a pipe fracture caused by fretting due to vibration or over tightening. The hot exhaust is available as the source of ignition because the insulation is either not adequate, already oil soaked or has not been fitted correctly. Often, as can be seen from the picture below, the insulation is not there at all. For example, the turbo charger has just been overhauled or the generator has been opened up for survey and the insulation has not yet been replaced. Fuel or 'lub' oil pipe failure can occur at any time resulting in a major engine room fire.

Generator exhaust – without any insulation; a major safety defect

SOLAS states that 'all surfaces above 220 deg Celsius which may be impinged as a result of a fuel system failure shall be properly insulated'. Consider also the exhaust insulation near lubricating oil pipes. A fractured lubricating oil pipe can as easily cause a fire as a fuel oil pipe fracture.

1. Masters should perform a weekly or fortnightly inspection that should include an inspection of the engine room. The master should not leave the inspection of the engine room to the chief engineer alone. The master can see if there are any major defective housekeeping issues, fuel/water/lub oil leaks, defective safety barriers and poor protective insulation on hot exhausts. Take a proactive approach to safety.

5. Consider as a company procedure that old insulation is always replaced with new insulation material. Trying to save a few dollars in not replacing damaged/unfit insulation is definitely not cost effective.

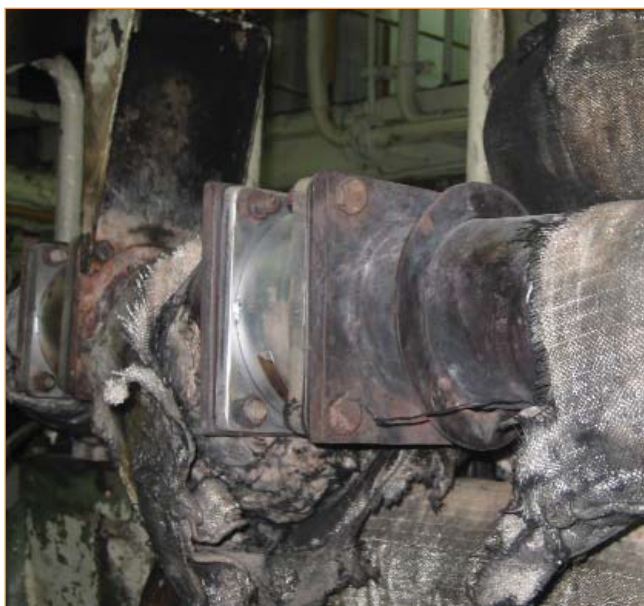
Another example – a major safety hazard

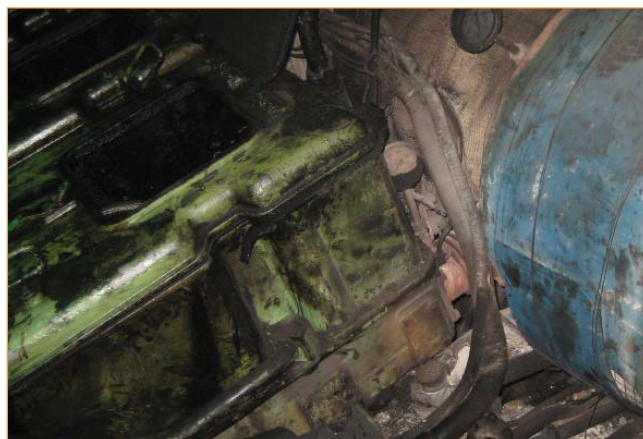
A dirty engine room is an unsafe engine room

2. Good housekeeping is a major loss prevention tool. Keeping the engine room and other spaces clean, tidy and free of oil is vital for a safe ship.
3. Include, as part of a machine overhaul, a risk assessment requiring that the chief engineer checks that the insulation has been correctly replaced and fitted after the overhaul. Masters should know who checks that the insulation material has been correctly fitted.
