# Standard Safety

February 2010

## Introduction

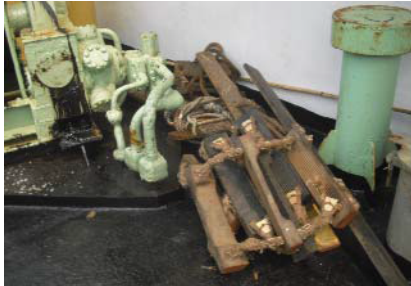
**DO NOT STOW LADDERS ON OPEN DECKS**

Routine maintenance inspections of pilot ladders should be a part of the ship's planned maintenance system. Pilot ladders must be stored in an appropriate dry space. Do not store ladders on an open deck where the elements can degrade the ropes.

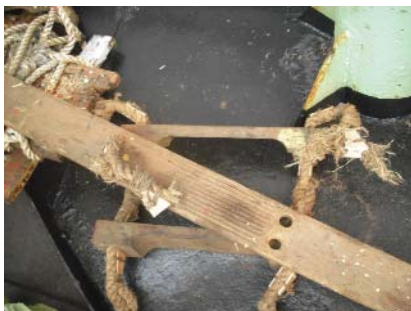
- the ropes between two steps were broken
- the rope near another step was parted
- the ladder was stored out on the open deck

**BROKEN LINES BETWEEN STEPS**

Pilot ladders with damaged ropes and/or ladder steps or spreaders must not be used. Damaged pilot ladders must be replaced. Do not use a damaged pilot ladder.

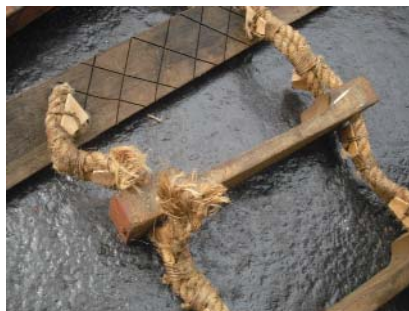
**TOP PART OF THE LADDER DAMAGED**

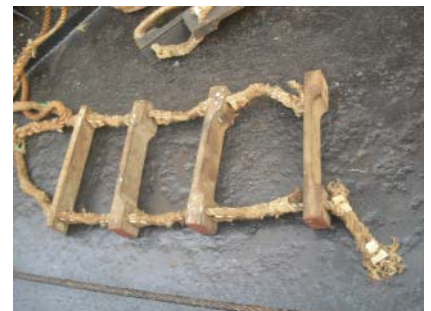
**BROKEN LINES NEAR STEPS**

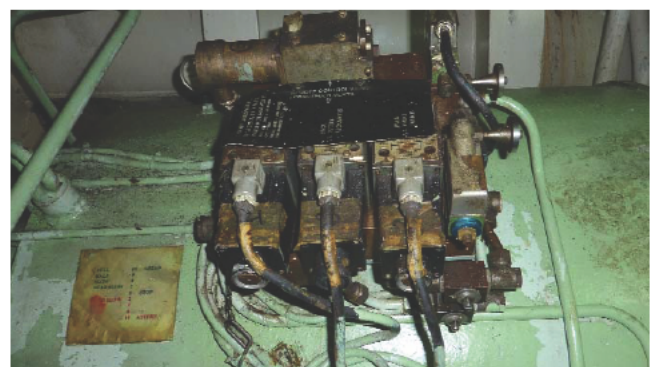
Ideally, a CPP failure position would be zero blade pitch (no thrust). However, all systems are at risk if, for example, a solenoid valve sticks in either the ahead or astern position during critical operations.

**CPP SOLENOID VALVES – OFTEN A CAUSE OF FAILURE**

- check all electrical connections are tight (solenoid valve plugs)
- ensure no air or hydraulic oil leakages are evident (loose control piping)
- test emergency manoeuvring system prior to port entry/departure
- consider renewing system solenoid valves every docking to ensure that they do not become worn and thus possibly stick during operation (see Figure 1, CPP solenoid valves)
- keep system oil clean (filtration and oil analysis)
- ensure ship's crew are well rehearsed in procedures in the event of a CPP failure during critical operations
- ensure that alarms are activated on the bridge consol and engine room consol when there are electrical/hydraulic CPP failures, alerting officers to the fact that there is a failure

A good maintenance and inspection regime for the CPP system can prevent a system failure and help to avert a potentially serious incident.

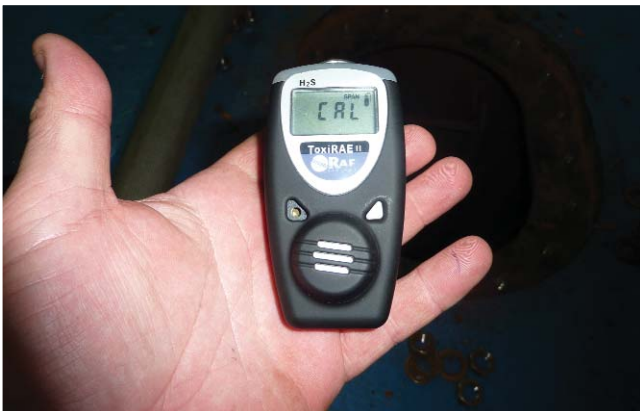
PORTABLE HAND HELD O<sub>2</sub> METRE

A H<sub>2</sub>S meter is not suitable for ballast tank entry. A calibrated oxygen meter must be used.

Does your ship have a calibrated O<sub>2</sub> meter suitable for testing the atmosphere in an enclosed space? If not, it should be supplied immediately. O<sub>2</sub> and other meters should be regularly calibrated. Meters should be easy to use and clear instructions in their use should be available. The use of personal O<sub>2</sub> meters is recommended.

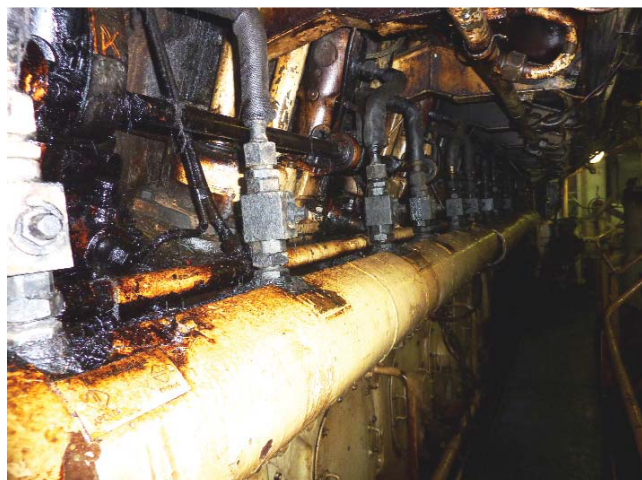
Compare this to a ferry of the same age – main engine oily and not being kept clean.

The ship with a dirty engine room indicates that there is a risk of fire, pollution and personal injury. It also indicates that the management does not consider these issues to be a high priority; it indicates that the maintenance is not being done as it should be.

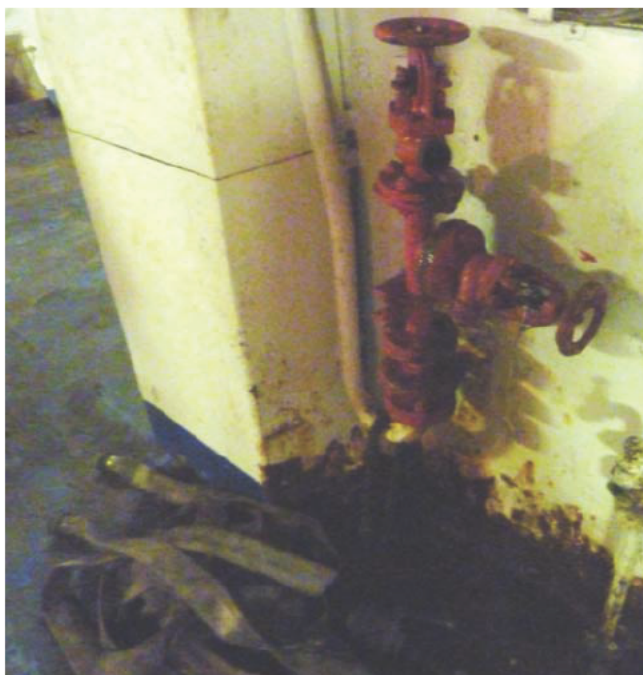
Poorly maintained equipment.

A ship with poorly maintained fire-fighting equipment indicates amongst other things that the safety management system is not working.

This is a fire water spray nozzle that is over-painted and unlikely to operate as designed. Not only should Class and Flag pick up on these types of defects, but the company and ship's personnel should ensure that these types of defects are rectified immediately.

Keep your fire-fighting equipment in good order; you may need it. Check your fire-fighting systems.

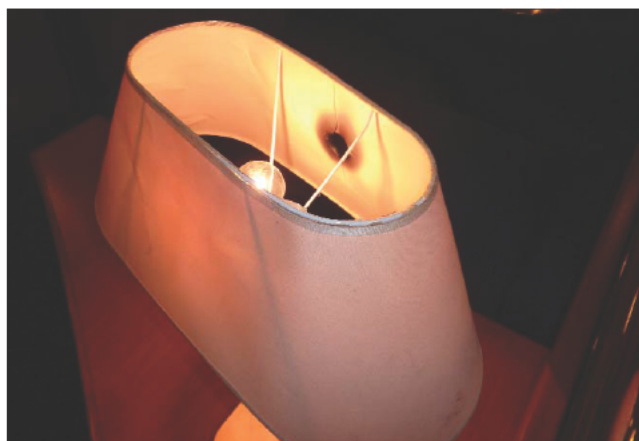
Fire safety is enhanced by good housekeeping. Electrical appliances, particularly in the accommodation, are a major source of ignition. The risk of a fire is reduced just by the simple task of ensuring that the ship is maintained, and kept clean and tidy, and potential fire hazards are removed. The picture below of a lamp inside passenger accommodation taken recently clearly shows defective equipment that a fire has or is about to occur. Remove the danger.

Accommodation inspections should be carried out regularly.

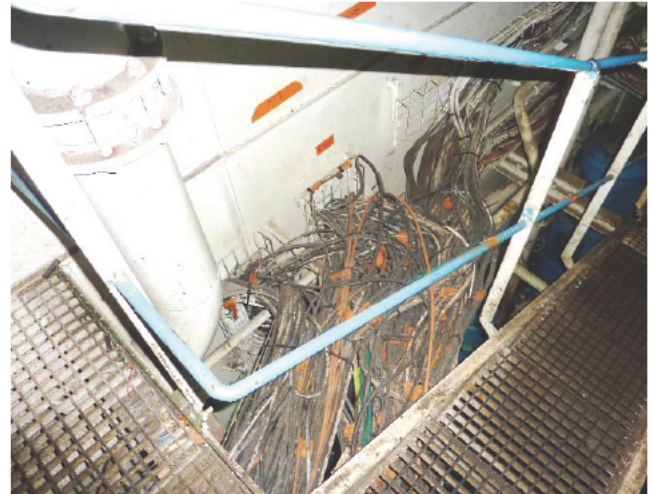
- there are junctions in the wires
- some of the wiring outer covering is damaged and bare wires are showing

It is obvious even to the untrained eye that this wiring is:

- not safe
- a significant electrical and fire hazard
- not in compliance with Class rules
- not in compliance with Flag State rules
- not in compliance with the ISM Code

There is no reason why this situation should have been allowed to continue without being rectified by the company. It is clearly a fire and personnel hazard, obvious to anyone inspecting the engine room.
