# FAKE EMERGENCY ESCAPE BREATHING DEVICES

The Marine Safety Forum (a group of shipping, logistics, energy, regulatory and other interests) issued its Safety Flash (11-09) on 8 March 2011 to warn the industry of the discovery of fake emergency escape breathing devices (EEBDs). The fake EEBDs were identified as copies of the Unitor/MSA type Uniscape 15H. The imitation sets do not work properly, and it is vital that shipowners ensure that their EEBDs are genuine and in good working order. The consequences of having fake devices on-board could be deadly: anyone using them will be unable to breathe and possibly unable to escape from an emergency situation.

# OVERWEIGHT RESCUE BOATS

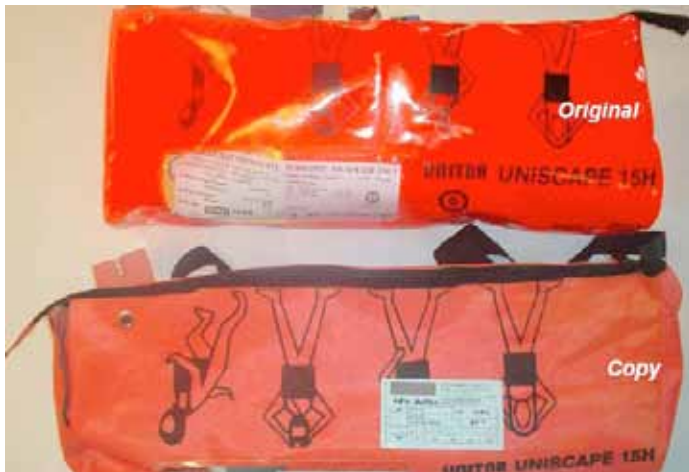
- bag material is different
  - original Unitor: shiny PVC material
  - fake Unitor: dull canvas-like material

^ Original and fake EEBD

Any EEBDs found to be forgeries should be taken out of service, and replaced immediately with genuine articles. The counterfeit EEBDs must be returned ashore so they cannot be used again.

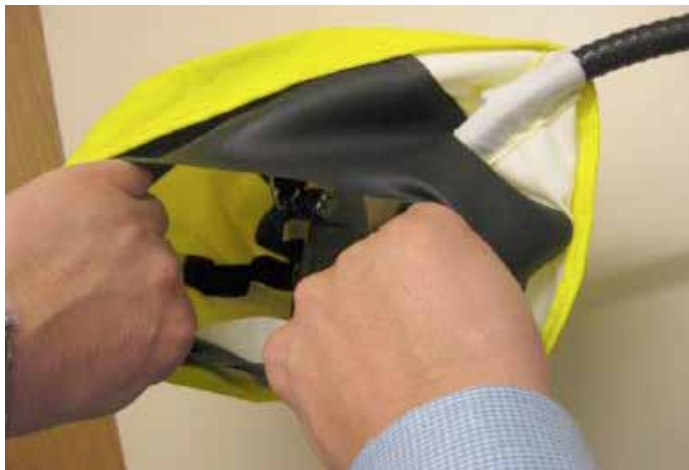
- mask hood will not fit over user's head. Neck-tightening rubber membrane is not flexible enough for a normal head size, and is sewn to the hood with a single seam – not welded as in an original Unitor hood

^ Mask hood and neck-tightening rubber membrane inadequate

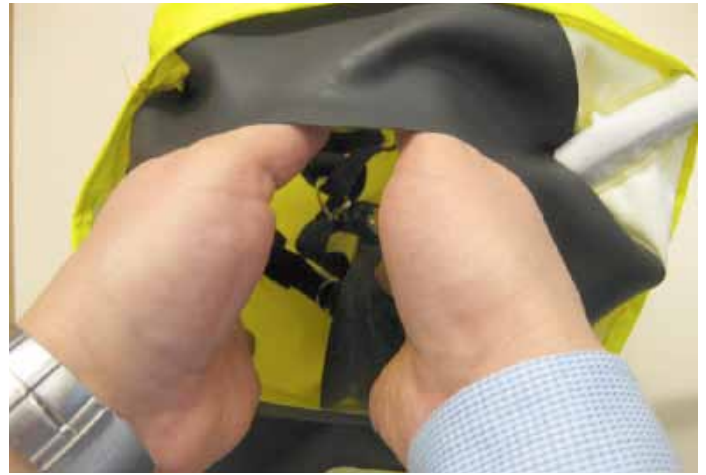
^ Mask hood and neck-tightening rubber membrane inadequate

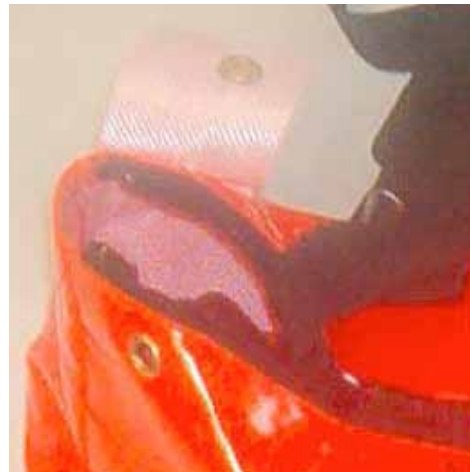
^ 2cm opening on original EEBD above

- zipper has 2cm opening on the teeth
- zipper closes from right to left

- zipper has no opening
- zipper closes from left to right. Air release cannot be activated automatically
