OVERWEIGHT RESCUE BOATS

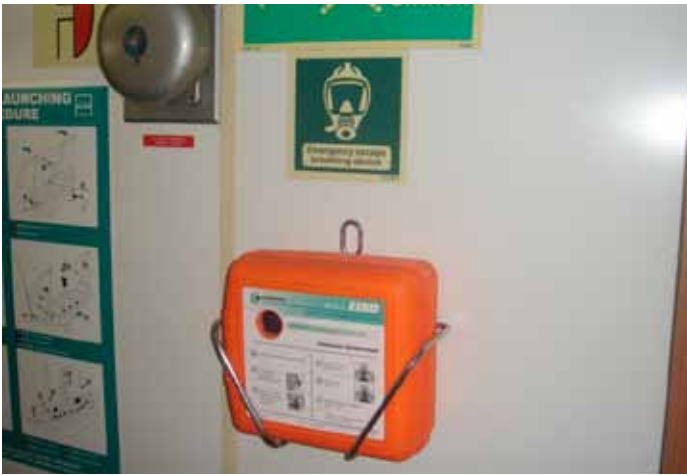
^ Example of a genuine EEBD in good working order

- ensure EEBDs are genuine and are in good working order
- take great care when ordering or servicing any life-saving or fire-fighting appliances. Always ensure genuine parts for fire and safety equipment by going to known service providers
- carry out periodic inspections of life-saving or fire-fighting appliances as per the on-board planned maintenance system (PMS). Retain records of these inspections
- check that life saving and fire fighting equipment is operational

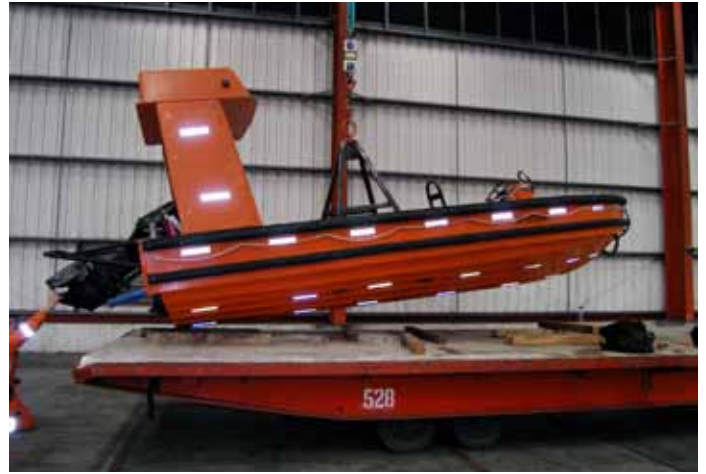
^ Weighing of overweight boat manufactured by Watercraft Hellas SA

The rescue boat was identified as a Watercraft WHFRB 6.50 and had a certified weight of 980kg. During the accident investigation, it was weighed and found to be 1450kg. Seven rescue boats of the same model used on sister ships were also inspected and found to be significantly heavier than when supplied. It was determined that the rescue boats' weights when un-laden were close to or exceeded the safe working load (SWL) of their davits; with the addition of crew, fuel and equipment on-board, the SWL of the davits were exceeded. The MAIB stated in its safety bulletin that the weight of the rescue boat *'by itself should not have resulted in the failure of its fall wire due to the safety margins in place. Investigation into the failure of the wire remains on-going.'*

- where any doubt exists, owners should contact the manufacturer, and arrange for the boat to be weighed
- owners of Watercraft WHFRB 6.50 boats should follow the guidance issued by the manufacturer. If guidance has not been received, contact the manufacturer immediately

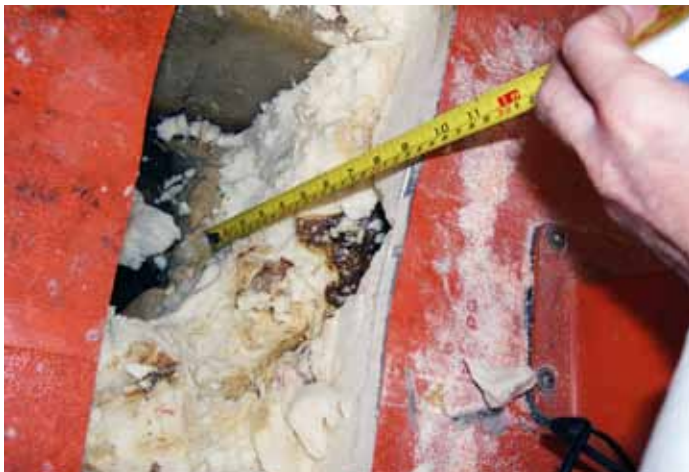
The MAIB found that 14 of the 15 foam-filled compartments in the rescue boat had been penetrated by water as well as lower sections of the hull containing cavities and voids between the foam and hull. The polyurethane foam was found in these areas to be of varying colour and consistency.

^ Inspection of the rescue boat below deck

- conduct regular inspections of rescue boats, paying particular attention to the hull and exposed decks for signs of degradation, including cracks, holes or any fittings through which water could penetrate

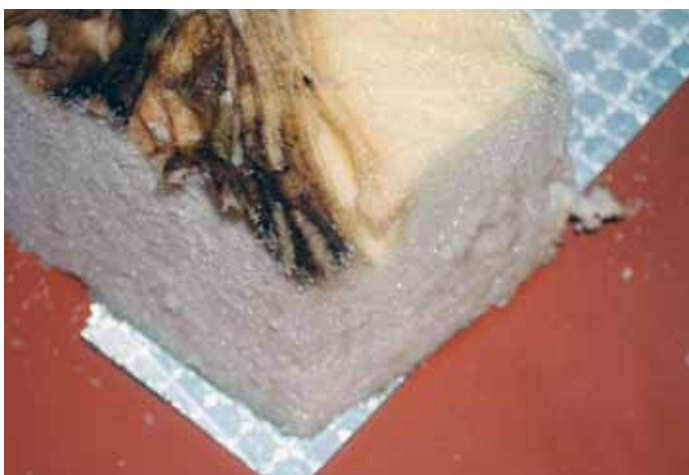
^ Sample of foam from cavity

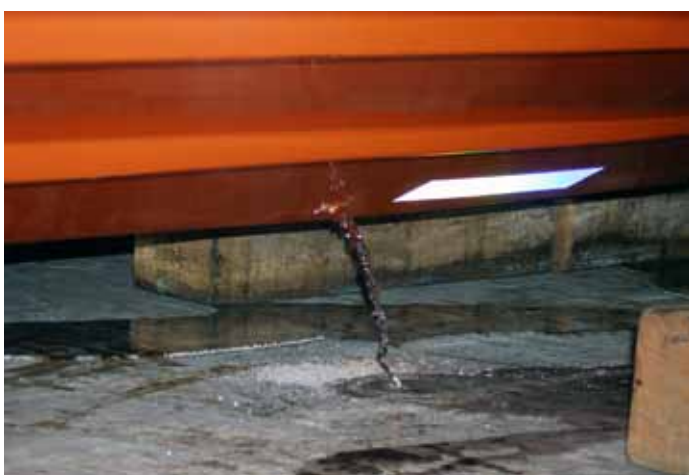
The rescue boat was fitted with a drain plug located on the transom, but the internal compartments were not interconnected. This meant that the aftermost compartment could be drained of water through the plug hole, but water present in the other compartments was trapped. The remaining compartments had to be drained by drilling separately into them through the hull.

^ Water draining from trapped compartment

- ensure that when rescue boats are in the stowed position, the drain plug is removed to allow water to drain away
