The Standard

STANDARD SAFETY

November 2011

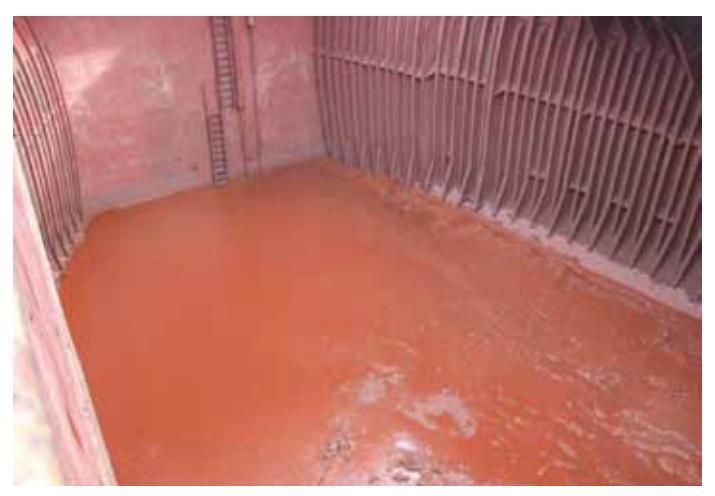
on the cargo declaration forms are wrongly classified as Group C cargoes. As a result, ships have suffered cargo liquefaction in their holds, with the moisture contents in excess of the transportable moisture limit (TML) and reaching it's flow moisture point (FMP). This has been confirmed at the discharge ports.

^ Liquefied sinter feed ore

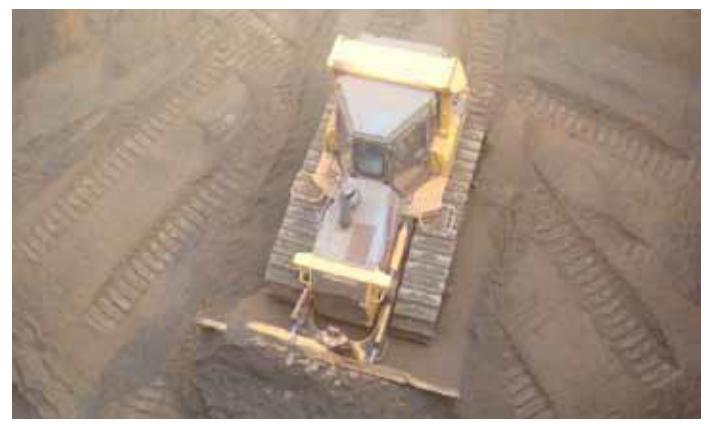
^ Bulldozer trimming sinter feed ore inside a cargo hold at Santana, Brazil

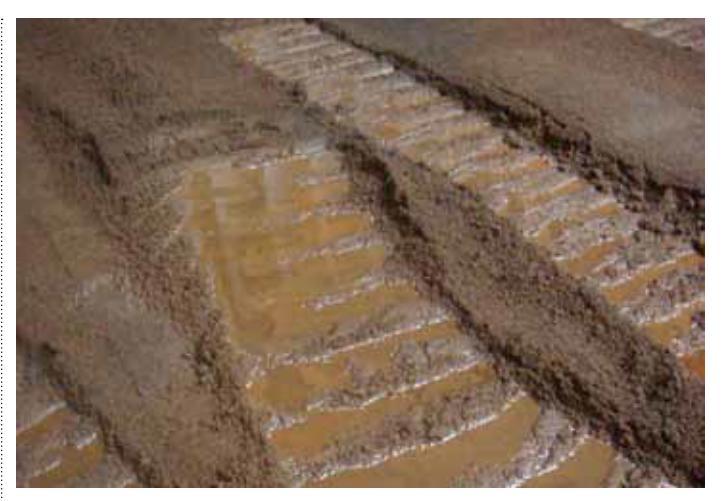
^ Water seen in the tracks of a bulldozer during trimming of sinter feed ore at Santana, Brazil

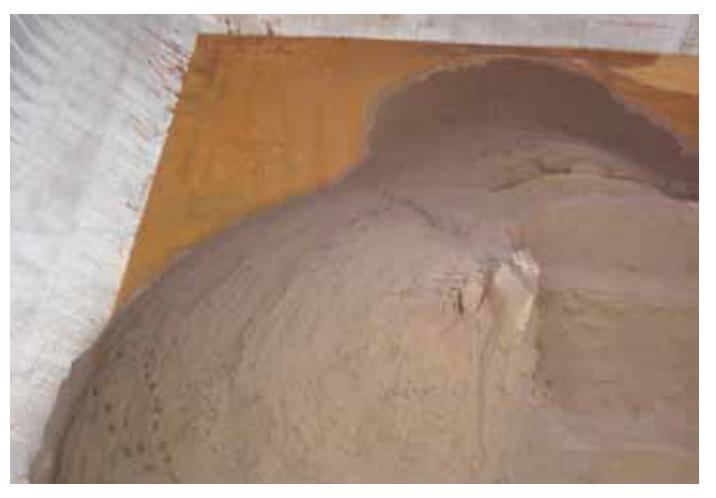
^ Signs of water in the cargo hold during loading of sinter feed ore at Santana, Brazil

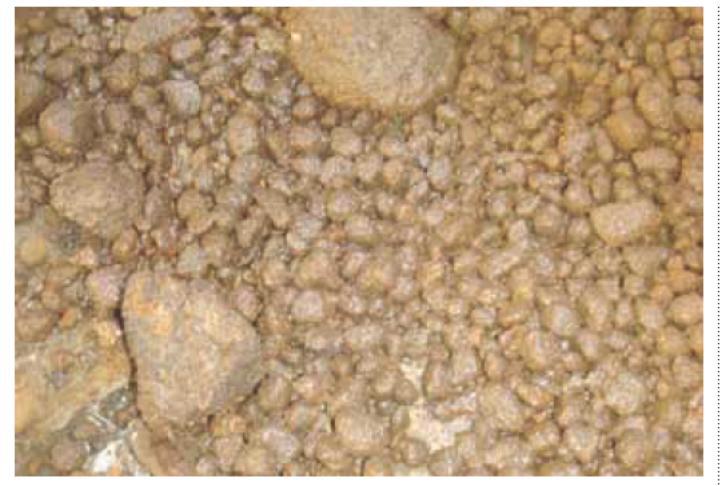
^ Sinter feed ore with high moisture content

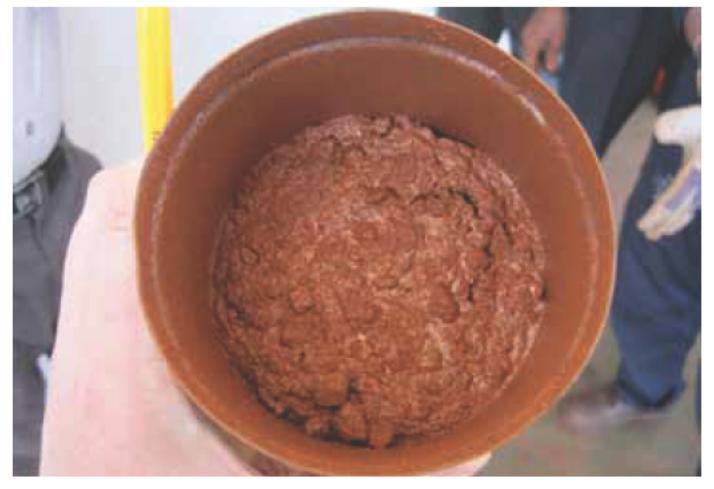
^ Can test showing a sample of iron ore fines with signs of water

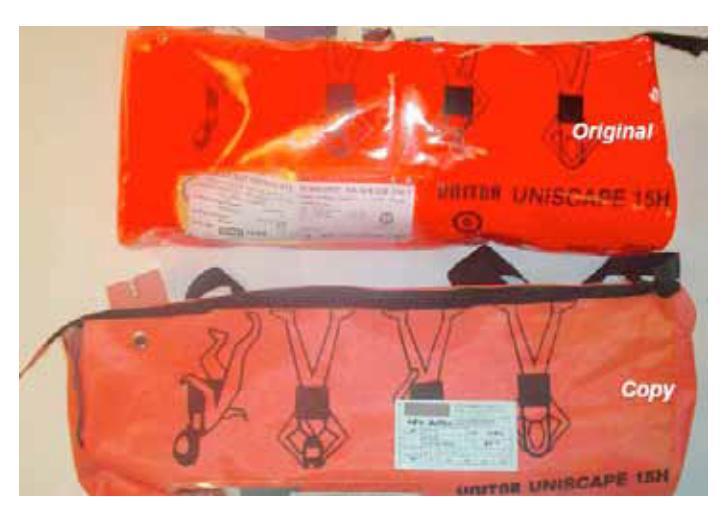
- bag material is different
 - original Unitor: shiny PVC material
 - fake Unitor: dull canvas-like material

^ Original and fake EEBD

Any EEBDs found to be forgeries should be taken out of service, and replaced immediately with genuine articles. The counterfeit EEBDs must be returned ashore so they cannot be used again.

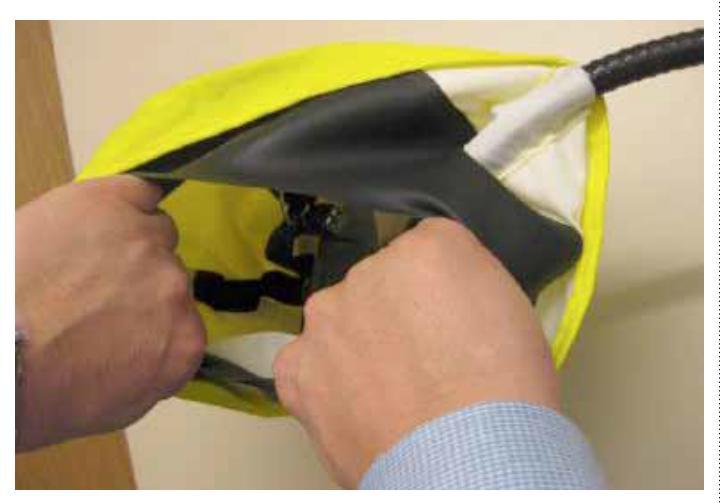
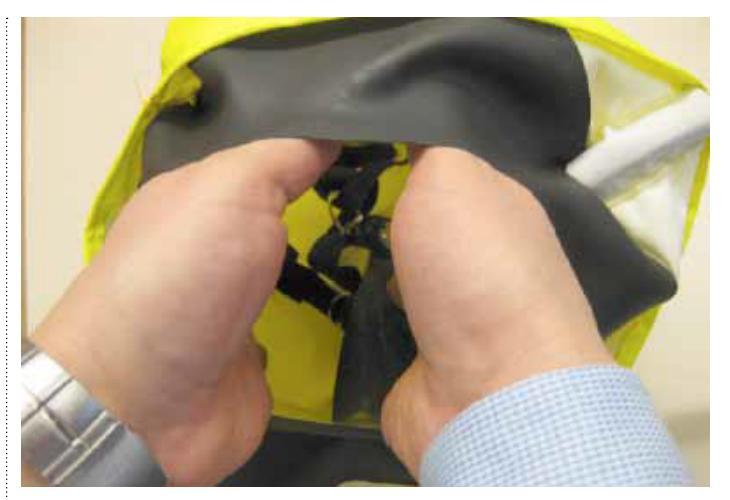
mask hood will not fit over user's head. Neck-tightening rubber membrane is not flexible enough for a normal head size, and is sewn to the hood with a single seam – not welded as in an original Unitor hood

^ Mask hood and neck-tightening rubber membrane inadequate

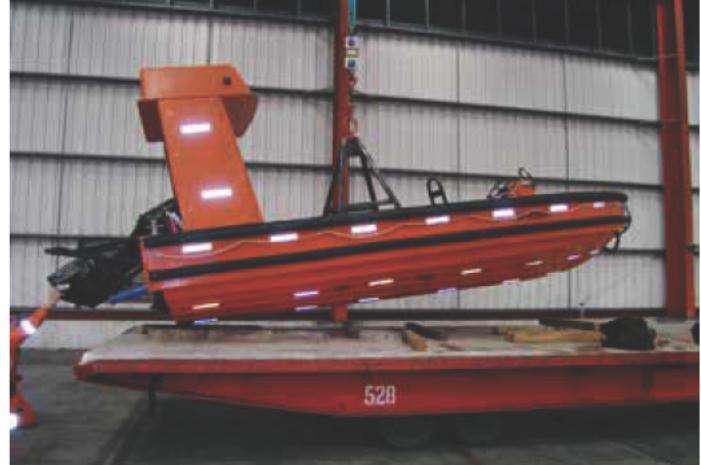
^ Weighing of overweight boat manufactured by Watercraft Hellas SA

The UK's Marine Accident Investigation Branch (MAIB) in its safety bulletin 1/2011 highlighted the dangers of rescue boats becoming overweight as a result of water penetration into void spaces. This problem caused a serious accident on a UK-flagged car carrier. During a routine drill, the fall wire attached to the rescue boat parted while it was being hoisted to its stowed position. The rescue boat and its four occupants fell nearly 29m into the water. One of the crew members died and two others were taken to hospital.

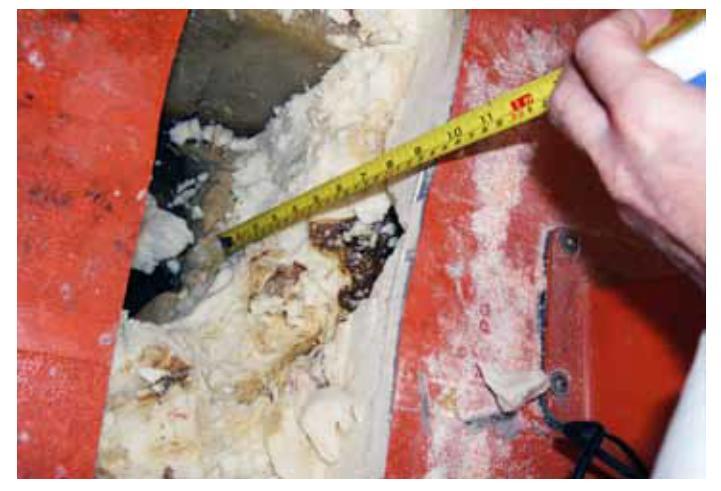
The MAIB found that 14 of the 15 foam-filled compartments in the rescue boat had been penetrated by water as well as lower sections of the hull containing cavities and voids between the foam and hull. The polyurethane foam was found in these areas to be of varying colour and consistency.

^ Inspection of the rescue boat below deck

- conduct regular inspections of rescue boats, paying particular attention to the hull and exposed decks for signs of degradation, including cracks, holes or any fittings through which water could penetrate

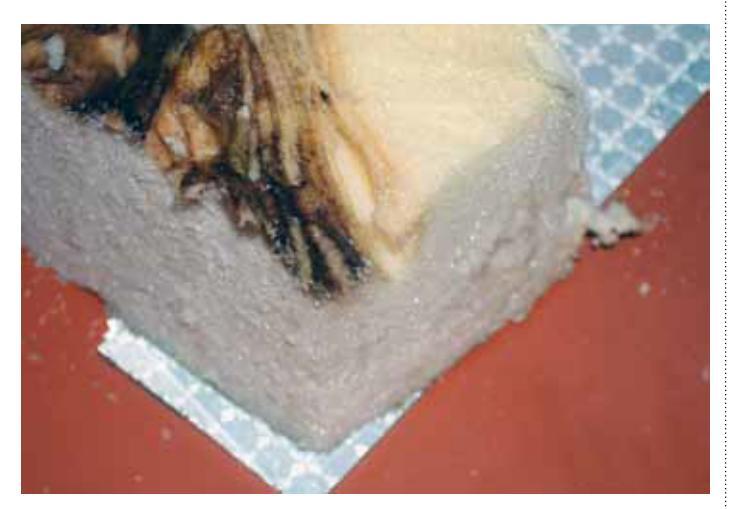
^ Sample of foam from cavity

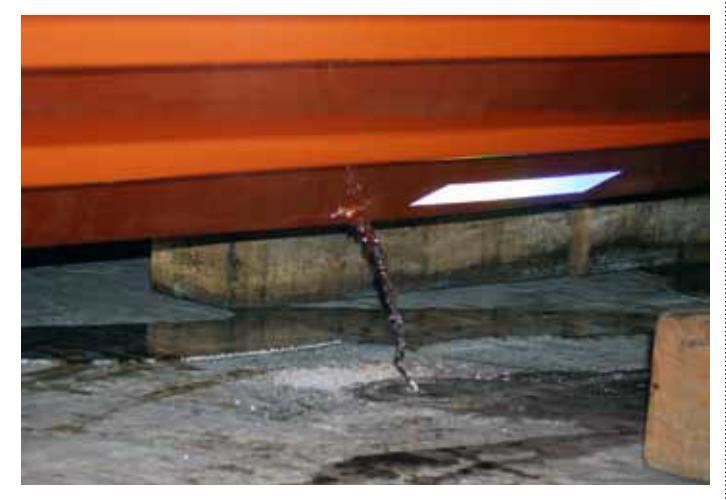
The rescue boat was fitted with a drain plug located on the transom, but the internal compartments were not interconnected. This meant that the aftermost compartment could be drained of water through the plug hole, but water present in the other compartments was trapped. The remaining compartments had to be drained by drilling separately into them through the hull.

^ Water draining from trapped compartment

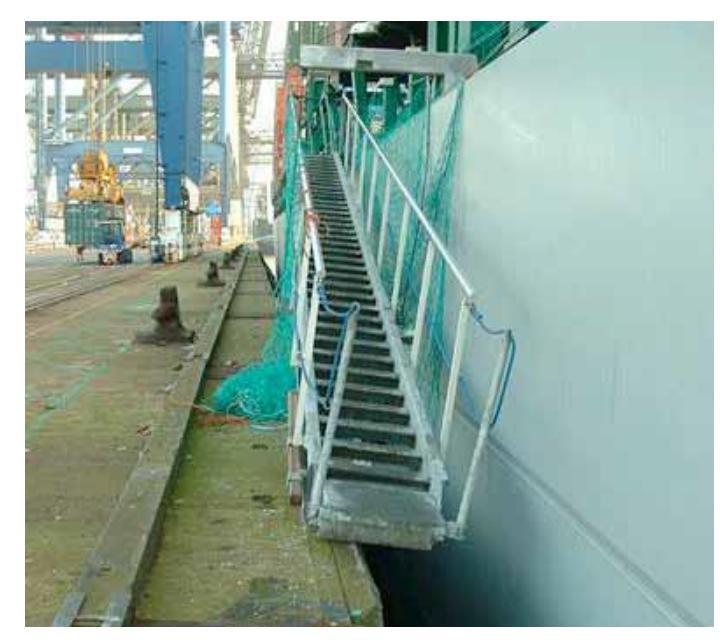
^ Dangerously placed gangway

Any of these defects on a gangway can lead to substantial claims for personal injury or fatality.

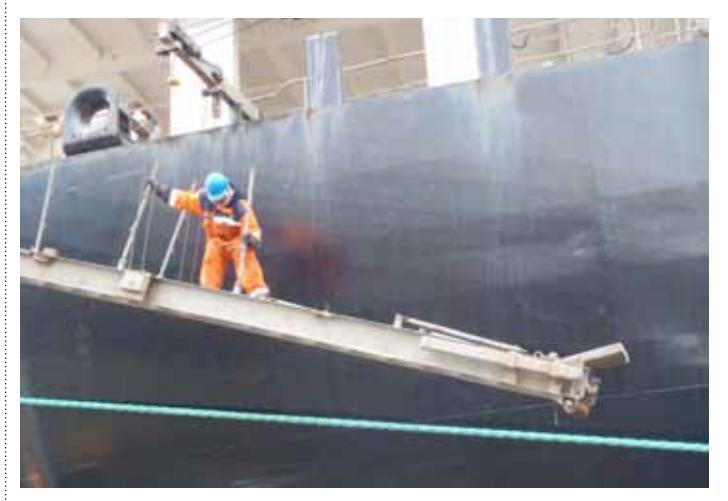
^ Rigging an accommodation ladder – no safety harness or fall prevention device in use – this is not a safe practice

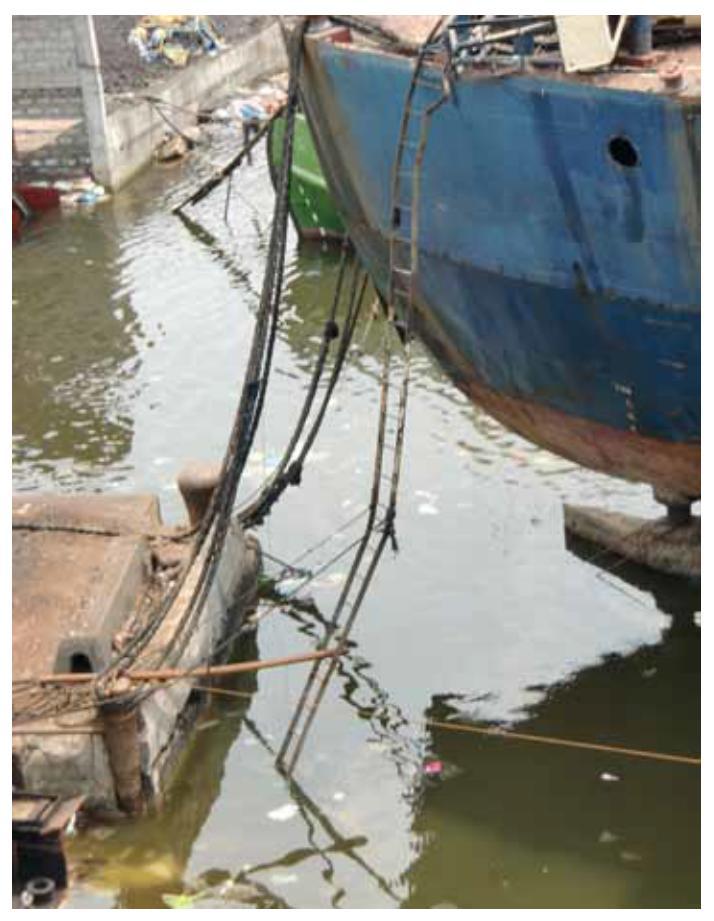
^ Ladders should not be used as a means of safe access to ships – this is not a safe practice

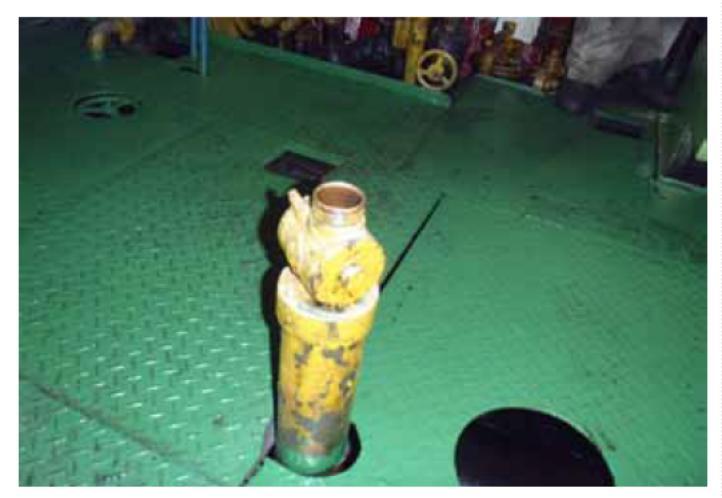
^ Weighted cap removed and screw cap off

The practice of leaving open self-closing sounding cocks by either removing the weight or by mechanically locking them open is dangerous and compromises the safety of the ship. It presents a high risk of flooding, pollution and fire; and is a serious deficiency that may lead to port state control detention.

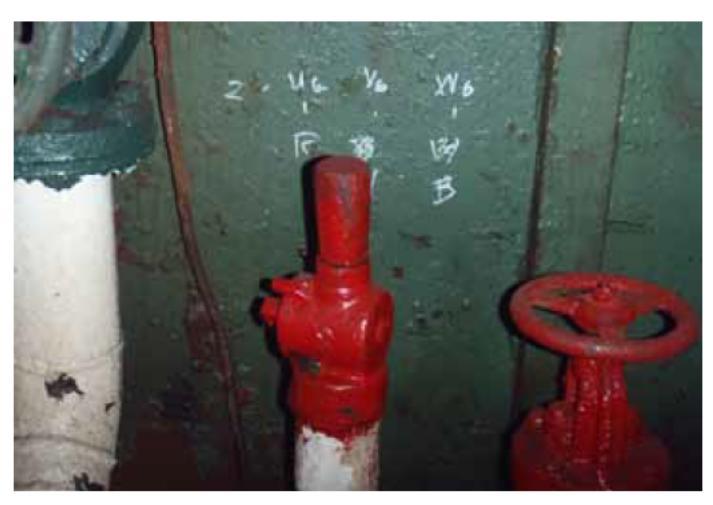
^ Screw cap replaced by wooden plug

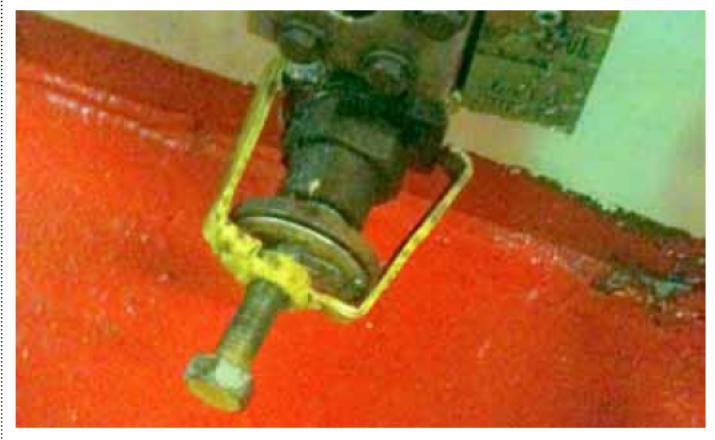
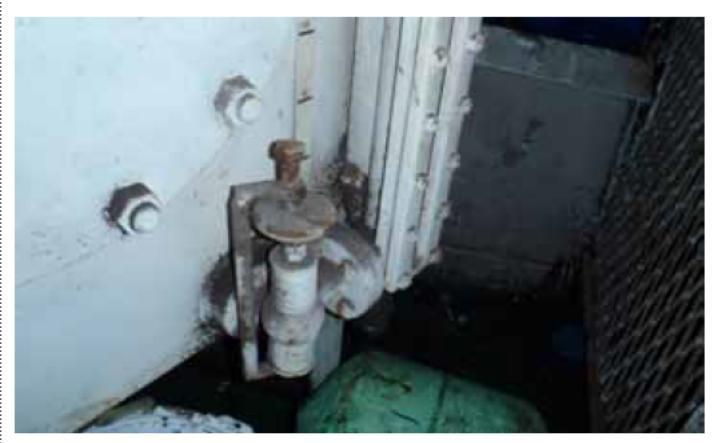
MECHANICALLY LOCKED OPEN LEVEL GAUGES

During surveys of machinery spaces, the club's surveyors have frequently noticed that self-closing weighted cocks for sounding pipes and gauge glass push buttons are being intentionally locked mechanically in the open position.

^ Mechanically locked open level gauges
