## **TRAINING STANDARDS**

# **BRIDGE WORK**

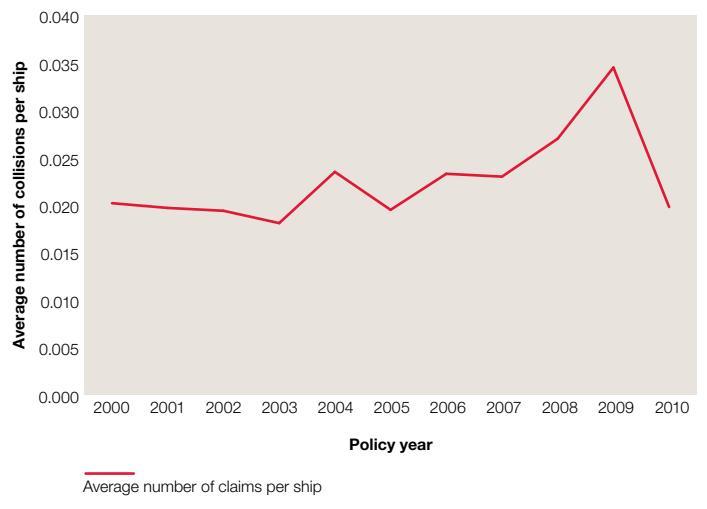
The club's data on collision claims shows that from 2000 to 2010, the average number of collisions per ship is steadily increasing – a near 50% increase. The graph below shows the average number of collision claims per entered ship.

^ Collision Claims 2000 to 2010. Average number of collisions per ship.

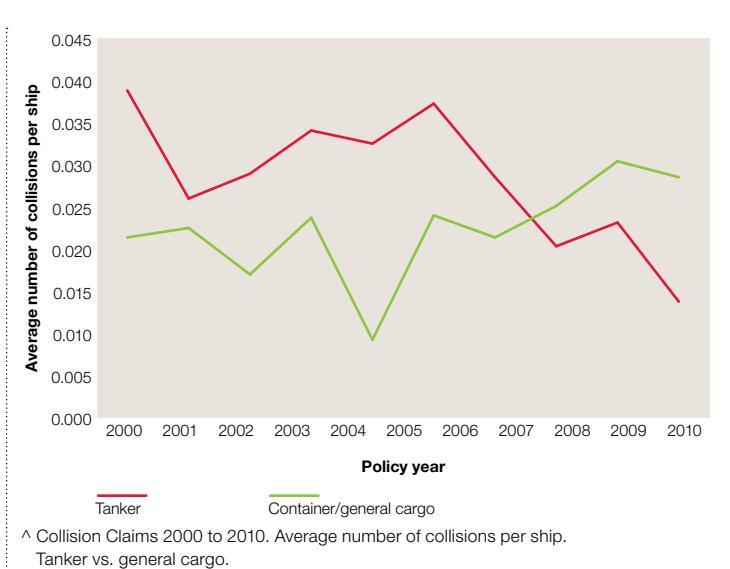
The following graph shows the average collisions per tanker ship vs the average number of collisions per container/general cargo ship for the last 10 year period.
