The Standard

STANDARD SAFETY

November 2011

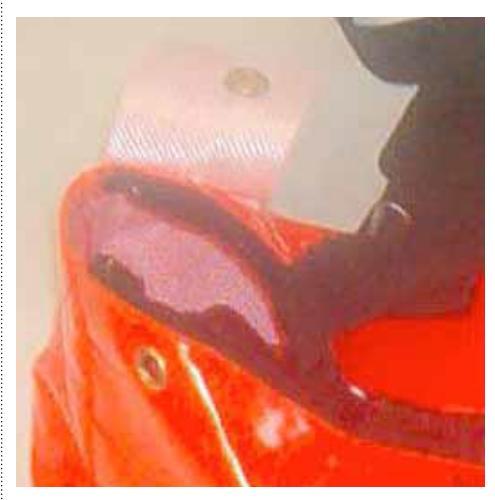
^ 2cm opening on original EEBD above

Any EEBDs found to be forgeries should be taken out of service, and replaced immediately with genuine articles. The counterfeit EEBDs must be returned ashore so they cannot be used again.
