# Standard Safety

## Special Edition - Navigation

September 2009

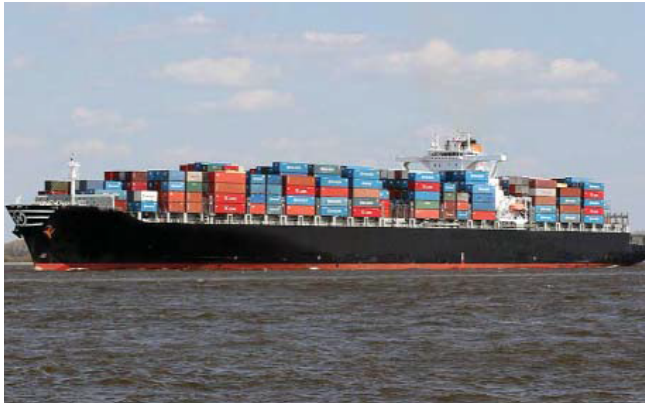
### 1. *Cosco Busan*

The 147-page incident report on the 2007 *Cosco Busan* collision with the San Francisco Oakland Bay bridge was published in May 2009 by the US National Transportation Board (NTSB). The report criticised the pilot's role in the incident, the master, ship manager and the port VTS.

The *Cosco Busan*, whilst navigating from the berth to sea with a pilot on board in restricted visibility, collided at 0830 hours with one of the base towers supporting the San Francisco-Oakland Bay Bridge, breaching a number of the ship's fuel oil tanks. This resulted in a spill of about 53,500 gallons of fuel oil, contaminating some 26 miles of shoreline. The total cost of the oil spill clean-up was in excess of \$70m, bridge repair \$1.5m and repair to the ship \$2.1m.
