Standard Safety

April 2009

Special Feature - Stowaways

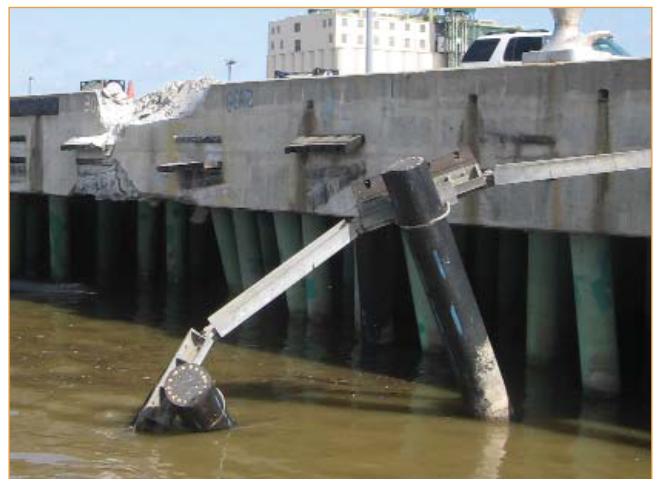
At this moment the engine staff – thinking that the ship had stopped – decided to immobilise the main engine to effect repairs. The pilot after a minute of stopped engines seeing that the ship was veering to starboard required 'ahead' engine movements to gain steerage. When the engines were put ahead there was no engine reaction. A phone call to the engine room revealed that the engine was immobilised. The ship was now moving at 1 to 2 knots through the water with the strong current from astern and veering more to starboard. Crew members were already on the forecastle ready to let go the anchor.

The master and pilot decided to let go the starboard anchor; the ship still veering to starboard, the anchor was let go but it was not possible to hold onto the anchor with the brake and the chain was ran out; the ship's speed hardly diminished. The main engine was soon brought back and an astern movement given but it was too late and the ship hit the T jetty, damaging foundation dolphins, and the terminal loading equipment. The cost of the two minutes of poor seamanship was weeks off hire, repairs to the ship and tens of millions of dollars for the repairs and lost revenue to the jetty.

- good communication is a Safety Tool – use it
- the master must take control of the situation at all times. He must command his ship. He must instruct the pilots and chief engineers under his command with vigour and authority
- chief engineers must never immobilise a main engine, particularly when navigating in a narrow channel or in restricted waters without the express permission of the master
- any change to the plan, even in this case the passage plan must ring the proverbial alarm bells. A changing situation is always a potential for danger
- windlass brakes must be inspected in the Planned Maintenance System (PMS). Windlass brakes should be tested every year to ensure that they are in a good condition
- shipowners must instil in their crews the basics of good seamanship
