# Standard Safety

February 2010

## Introduction

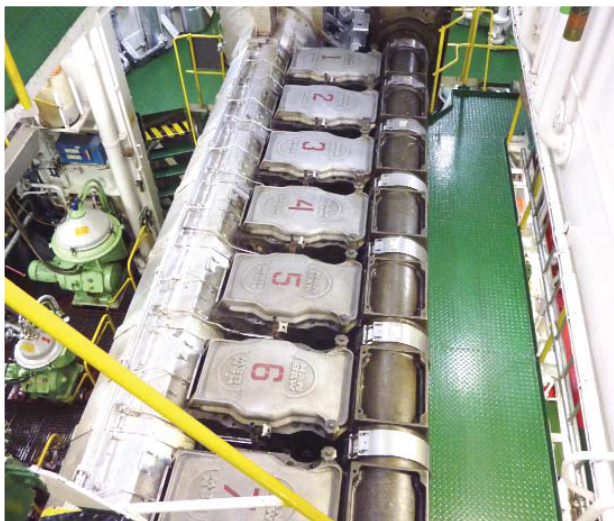
The picture below is from an 18 year old built general cargo ship on a busy trading schedule, with a normal complement of crew. The condition of the engine room is as clean as if new.

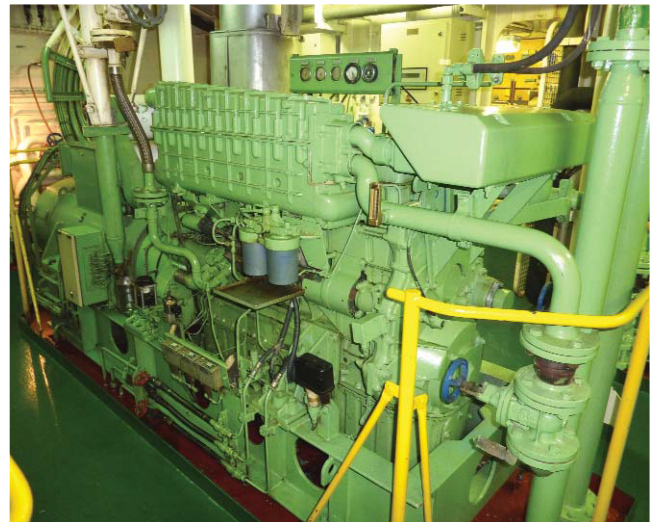
This is what a 16-year-old generator should look like. Keep your equipment well maintained so the risk of machinery failure, blackouts or fires are reduced. Poor generator maintenance has been the cause of major incidents including, fire, groundings, collisions, cargo loss claims, personnel injury and even total loss.

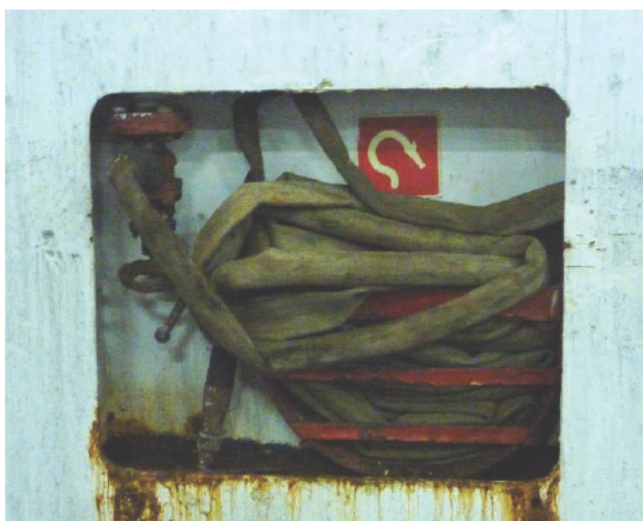
Poorly maintained equipment.

Look after your fire-fighting equipment; you never know when you may need it.

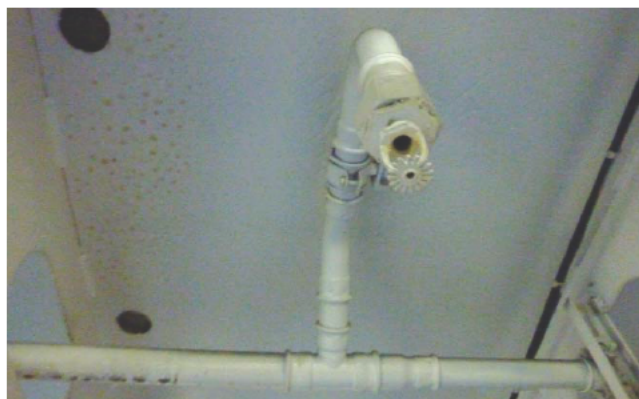
This is a fire water spray nozzle that is over-painted and unlikely to operate as designed. Not only should Class and Flag pick up on these types of defects, but the company and ship's personnel should ensure that these types of defects are rectified immediately.

Keep your fire-fighting equipment in good order; you may need it. Check your fire-fighting systems.
