# FAKE EMERGENCY ESCAPE BREATHING DEVICES

The Marine Safety Forum (a group of shipping, logistics, energy, regulatory and other interests) issued its Safety Flash (11-09) on 8 March 2011 to warn the industry of the discovery of fake emergency escape breathing devices (EEBDs). The fake EEBDs were identified as copies of the Unitor/MSA type Uniscape 15H. The imitation sets do not work properly, and it is vital that shipowners ensure that their EEBDs are genuine and in good working order. The consequences of having fake devices on-board could be deadly: anyone using them will be unable to breathe and possibly unable to escape from an emergency situation.

# OVERWEIGHT RESCUE BOATS

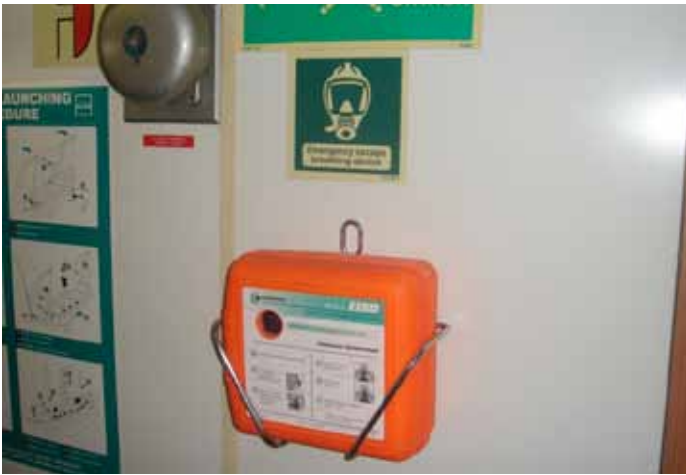
^ Example of a genuine EEBD in good working order

- ensure EEBDs are genuine and are in good working order
- take great care when ordering or servicing any life-saving or fire-fighting appliances. Always ensure genuine parts for fire and safety equipment by going to known service providers
- carry out periodic inspections of life-saving or fire-fighting appliances as per the on-board planned maintenance system (PMS). Retain records of these inspections
- check that life saving and fire fighting equipment is operational
