STANDARD SAFETY

June 2012

NAVIGATION SPECIAL EDITION

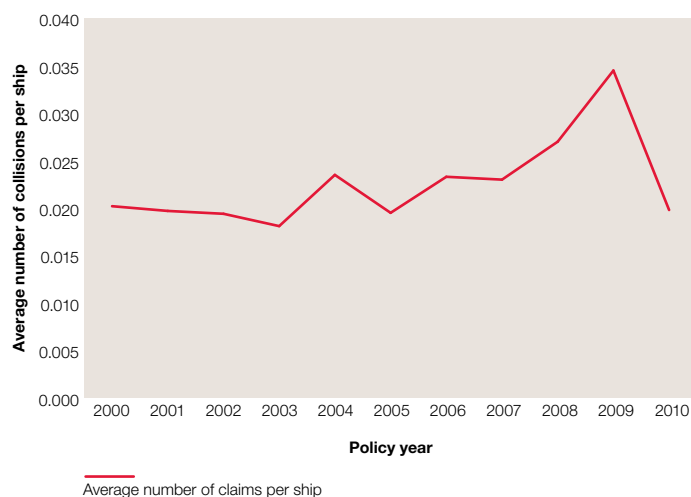
The club's data on collision claims shows that from 2000 to 2010, the average number of collisions per ship is steadily increasing – a near 50% increase. The graph below shows the average number of collision claims per entered ship.

^ Collision Claims 2000 to 2010. Average number of collisions per ship.

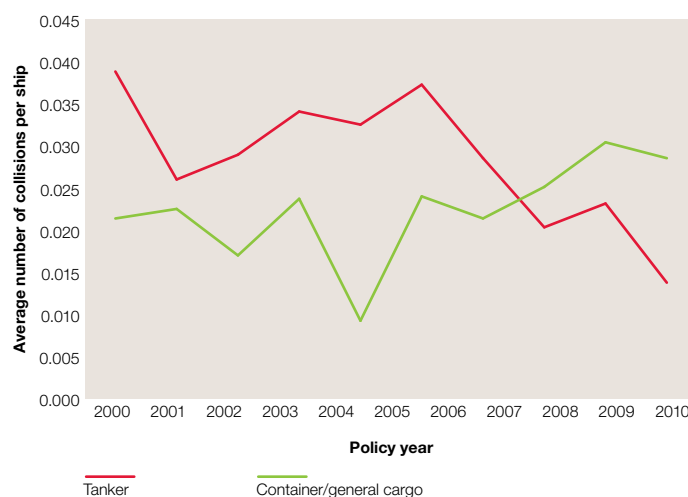
The following graph shows the average collisions per tanker ship vs the average number of collisions per container/general cargo ship for the last 10 year period.

^ Collision Claims 2000 to 2010. Average number of collisions per ship. Tanker vs. general cargo.

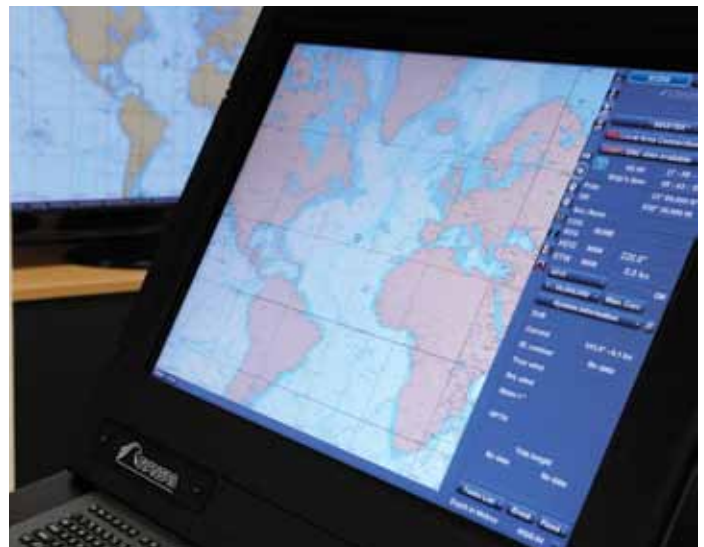
^ ECDIS – Image courtesy of ECDIS Limited

There is already evidence that the failure to understand ECDIS systems on board has been the cause of some groundings.
