Standard Safety

October 2014

MARPOL Annex 1

Breaking the error chain, part 1

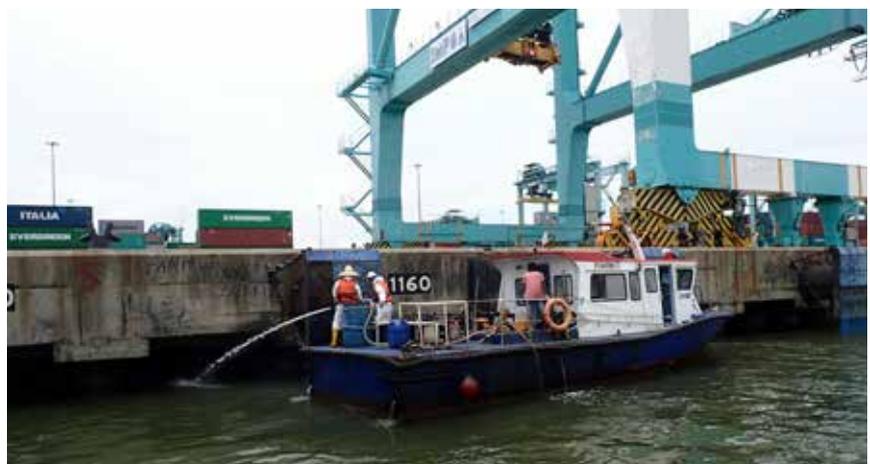
The cost from an error in a bunkering operation can be significant.
Source: ITOFF

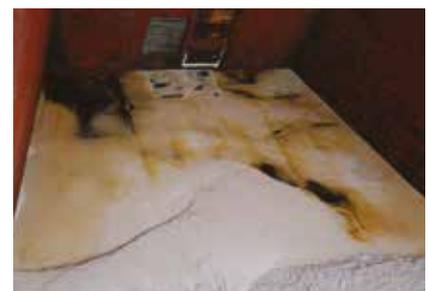
Water ingress via a faulty bilge valve will cause cargo damage

- although there was double valve segregation between the bilge and ballast pump line, one butterfly valve had a damaged seal and was leaking, while the other valve was not closed properly. It was blocked with residues of the previous cargo;
- the ship's officers were not familiar with the cargo hold bilge system or where the bilge and ballast systems were common;
- there were no cargo hold bilge high-level alarms;
- soundings had not been taken throughout the voyage.

It is essential that ships' officers are fully aware of how the bilge system functions. Of particular importance is the knowledge of the valves, especially isolating valves and cross-over connections between the bilge and ballast system.

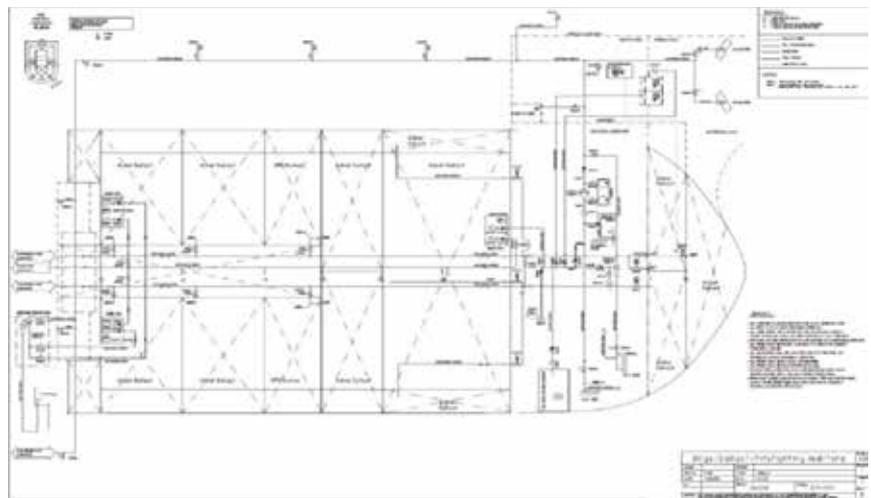
Get to know your bilge system

One of the most important tasks in hold preparation is to ensure that bilge wells, lines and valves are clean and in operational condition. Bilge lines must be tested by an experienced crew member to ensure that non-return valves are functioning correctly and not allowing back-flow into the cargo hold. If fitted, the bilge high-level alarm must be tested and confirmed as operational.
